AIRCRAFT ARMAMENTS, Inc.

STATUS REPORT

(14 October through
25 November 1961)

E41 GAS ALARM

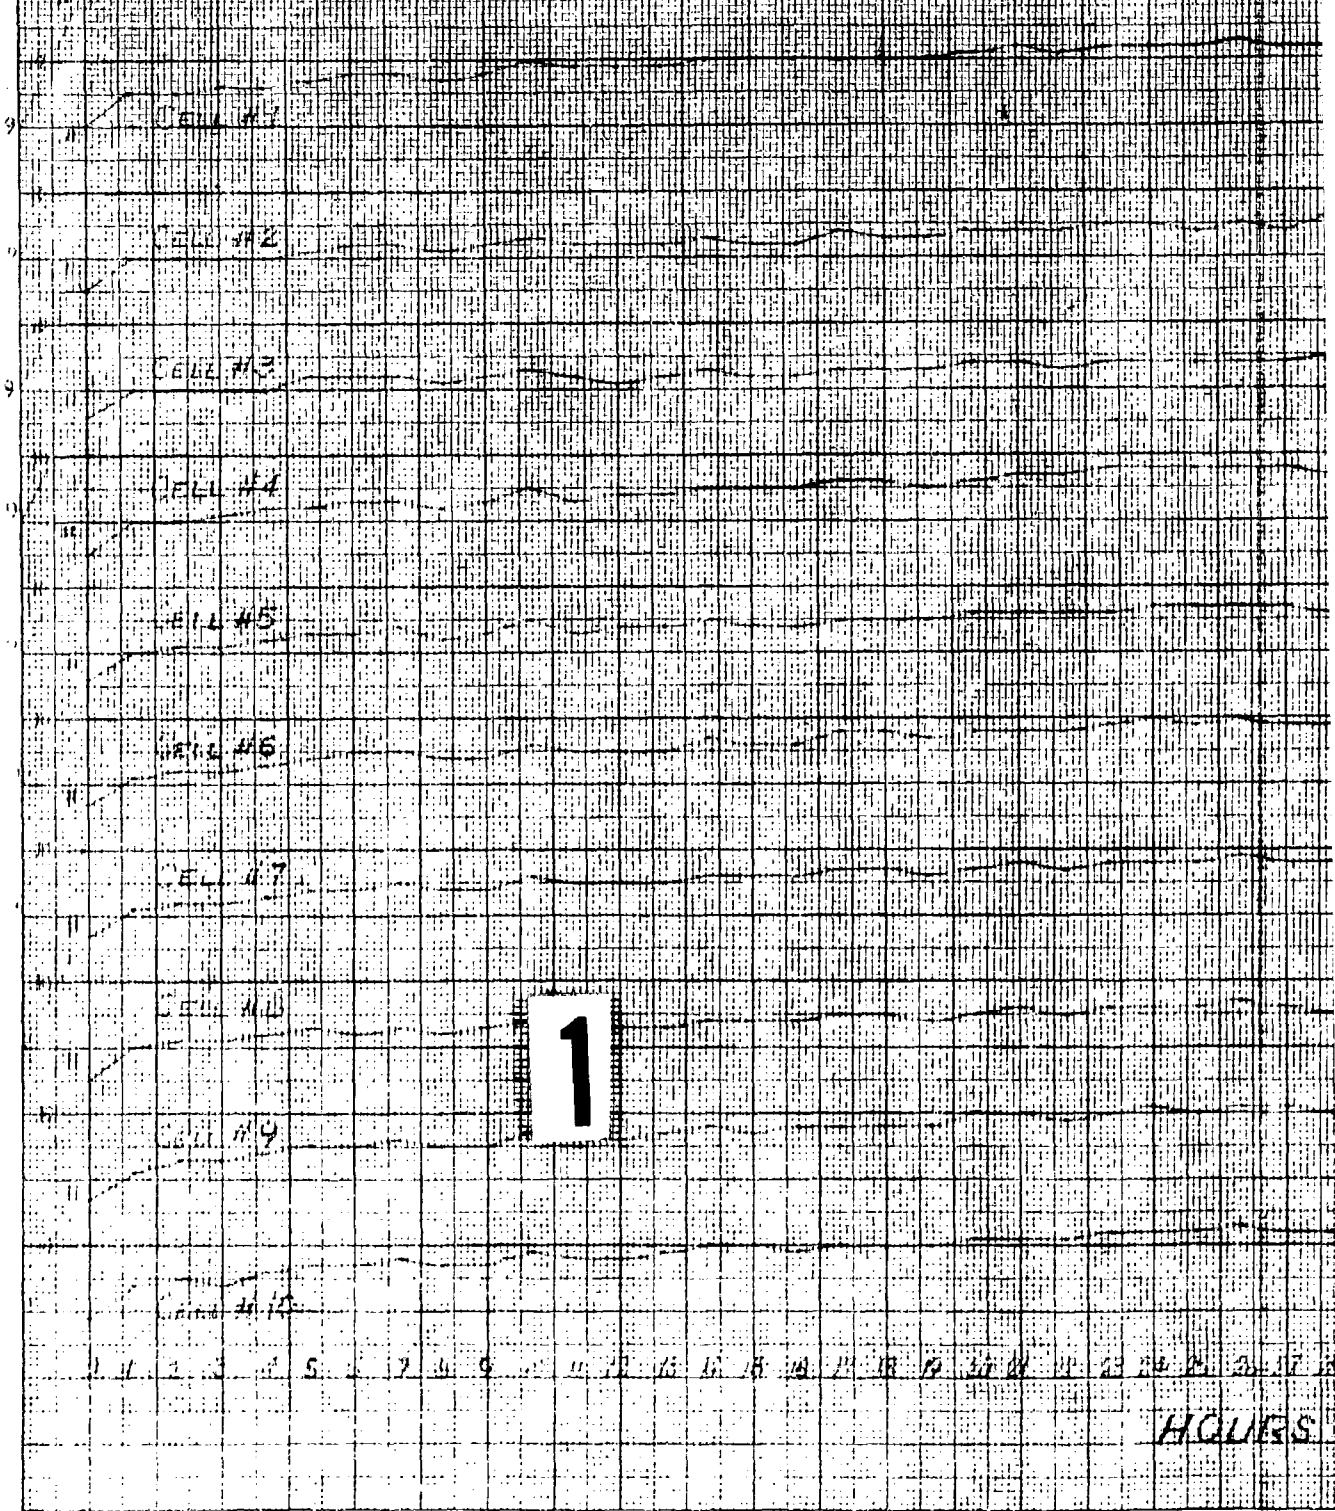
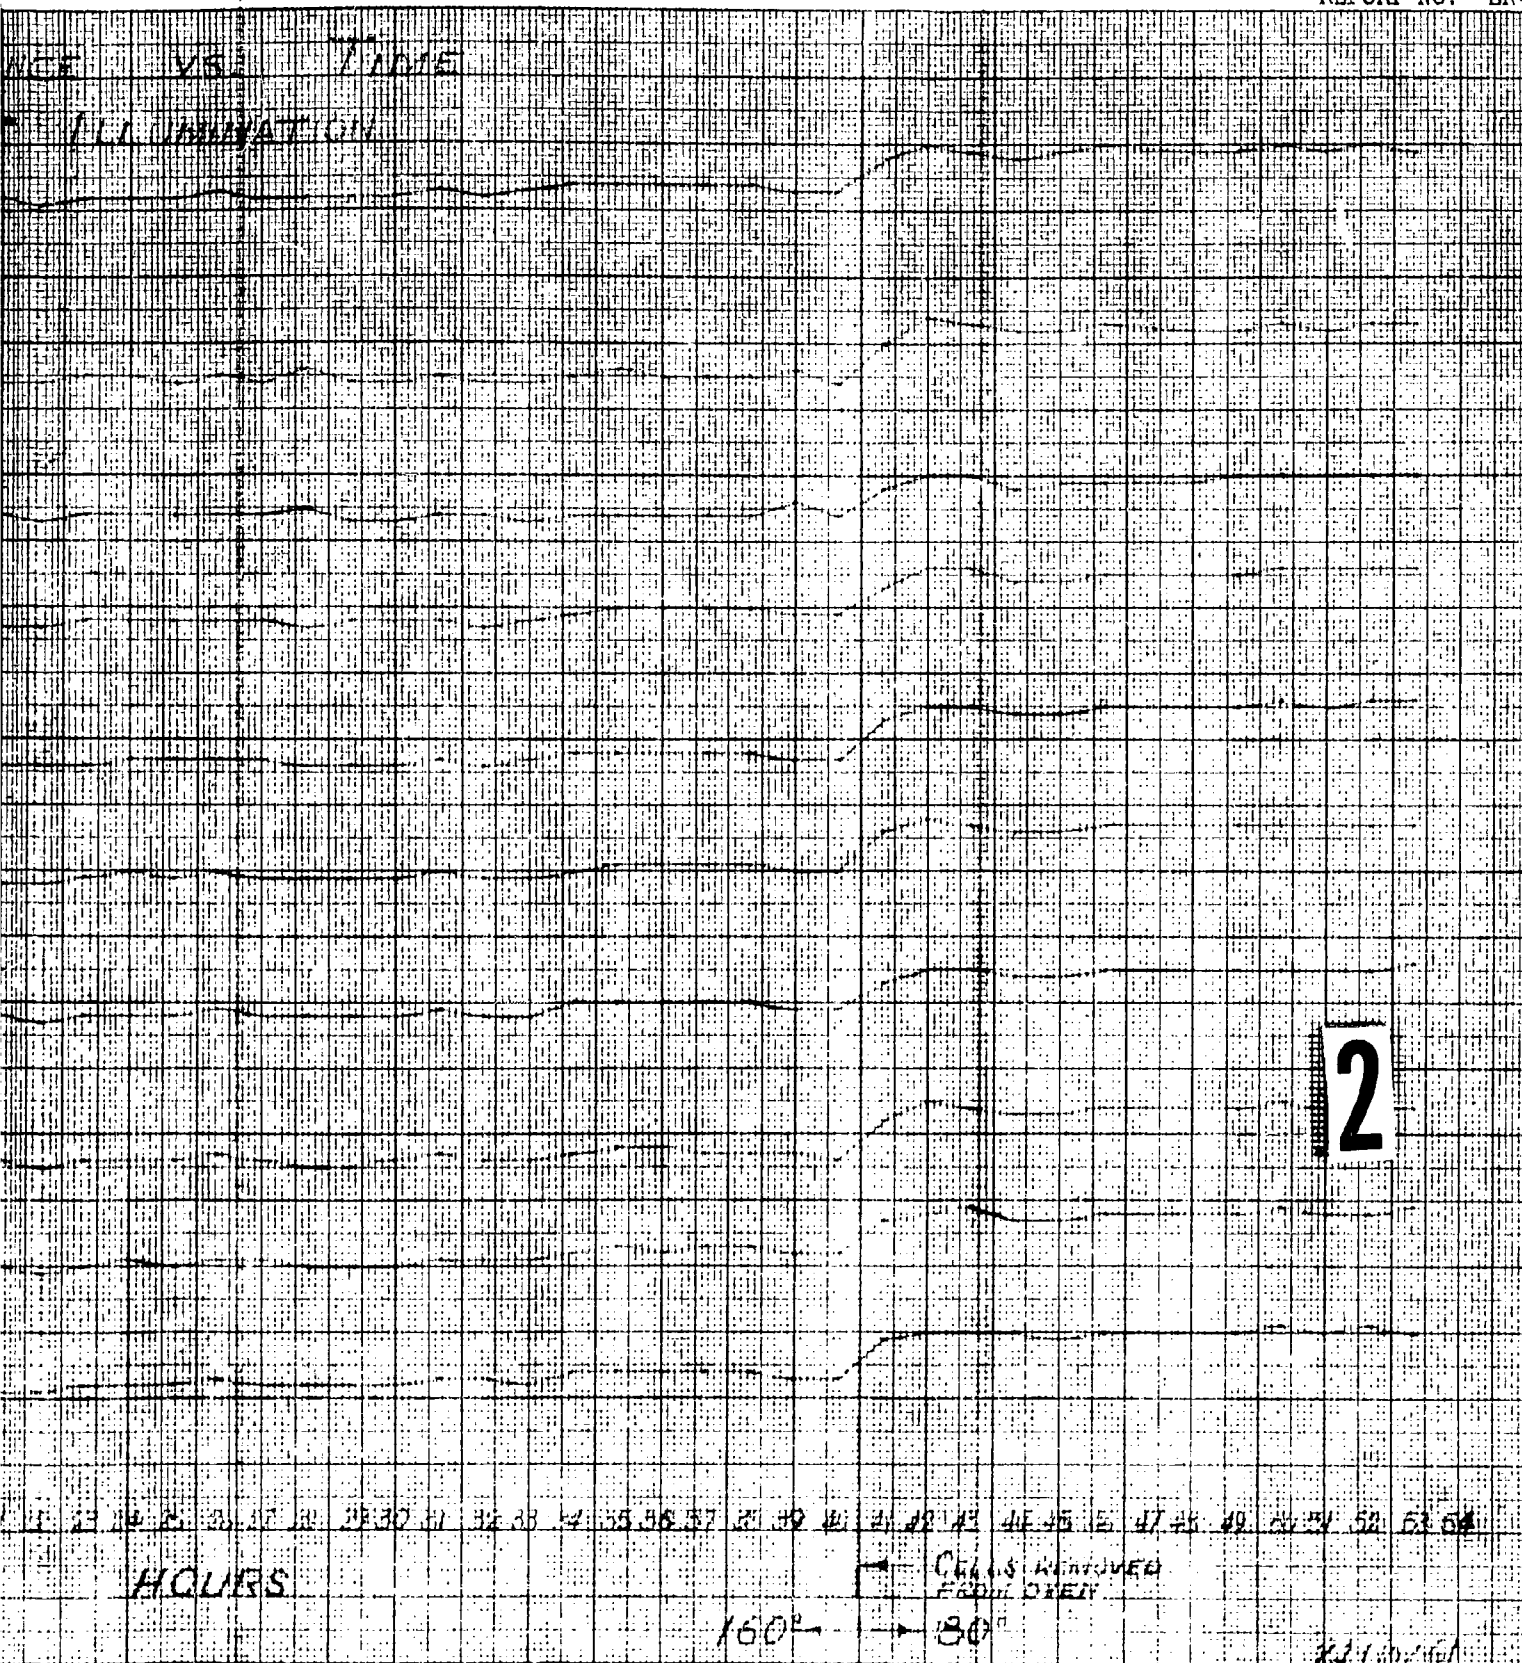
PHOTOCELL RESISTANCE VS AT CONSTANT ILLUMINATION

The first series of tests has been conducted on type CL605L photocells. First, the photocells were dark adapted for a 12 hour period at room temperature. Then the cells were operated for 24 hours at room temperature in an ambient light approximating that which the cells experience in the photometer head. During the course of this test, the cells exhibited no appreciable change in resistance.

A similar test was repeated with this CL605L cell batch at a temperature of 160°F. At the end of the high temperature running period, the cell bank was removed from the oven and operated for an additional period of time at room temperature. The results of this test run at elevated temperature were significantly different from those obtained in the room temperature test. During the high temperature operation there was an unmistakable drift in the upward direction of the resistance of all cells. The rate of drift varied among cells of the test batch between 5.3% and 10.4% in a 24 hour period.

The fact that no recovery was exhibited by the cells upon removal from the high ambient temperature indicates that photofatigue appears to be of more importance than temperature sensitivity. Likewise, photofatigue appears to be much more pronounced at higher temperatures. A graph illustrating individual cell behavior during this test is shown as Figure 1.

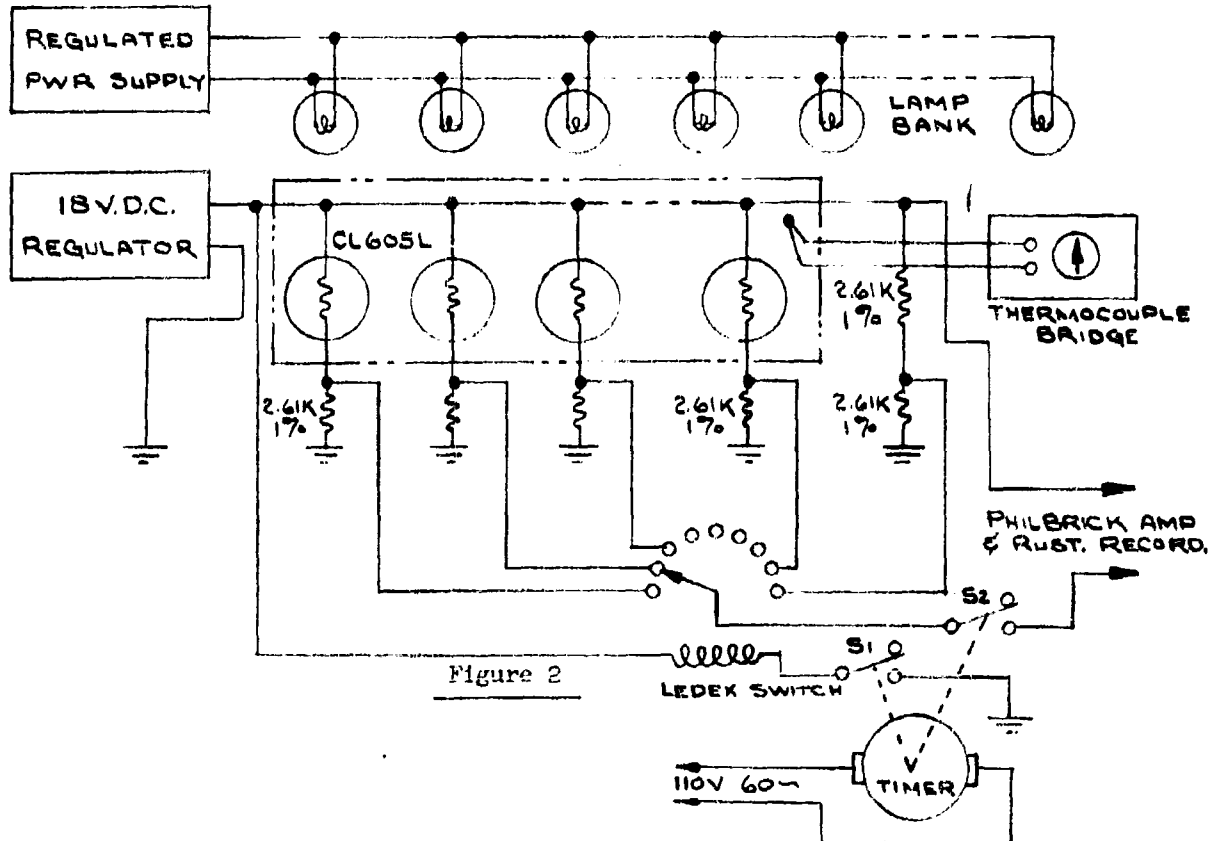
CIRCUIT:

Lamp voltage is adjusted until photocells have resistance approximately equal to series resistors. Amplifier input is then nominally 9 volts.

S1 closes momentarily every 30 seconds to advance ledex switch. S2 opens as S1 closes and remains open for about 10 seconds. This provides an interruption to Rustrak input, thus facilitating identification of the marks on Rustrak recorder tape.

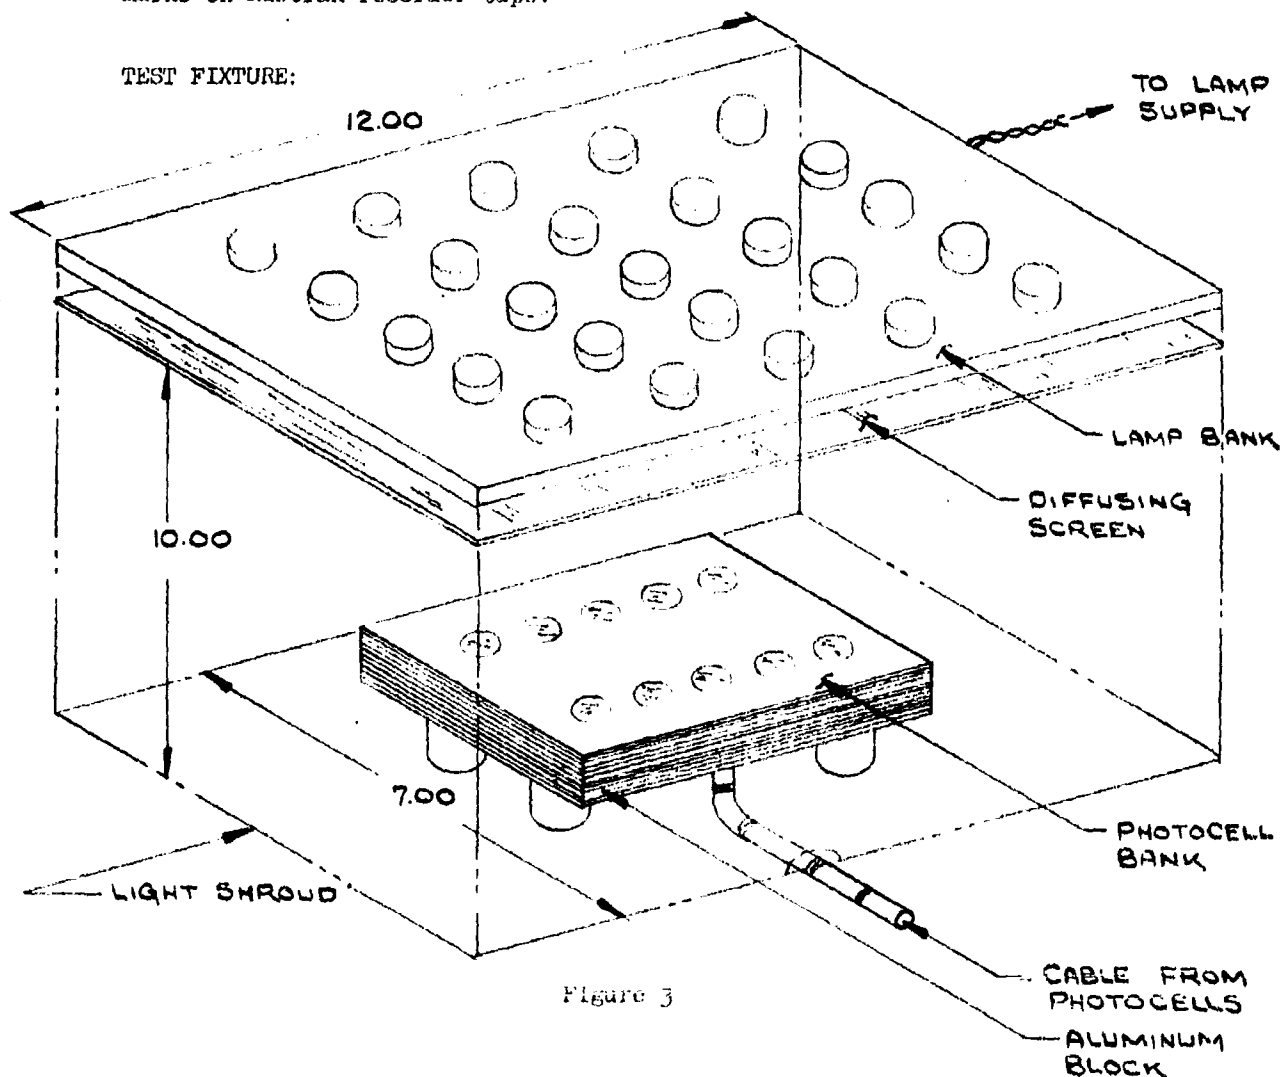
Figure 3

Reexamination of the problem and evaluation of previous data indicated the photocells were a prime suspect as the source of drift. Therefore, the design of the photocell test fixture was improved to eliminate experimental errors, and a photocell test program outlined for testing CL602 and CL605L photocells. A description of the apparatus and testing procedure is included with this report. See Figures 2 and 3.

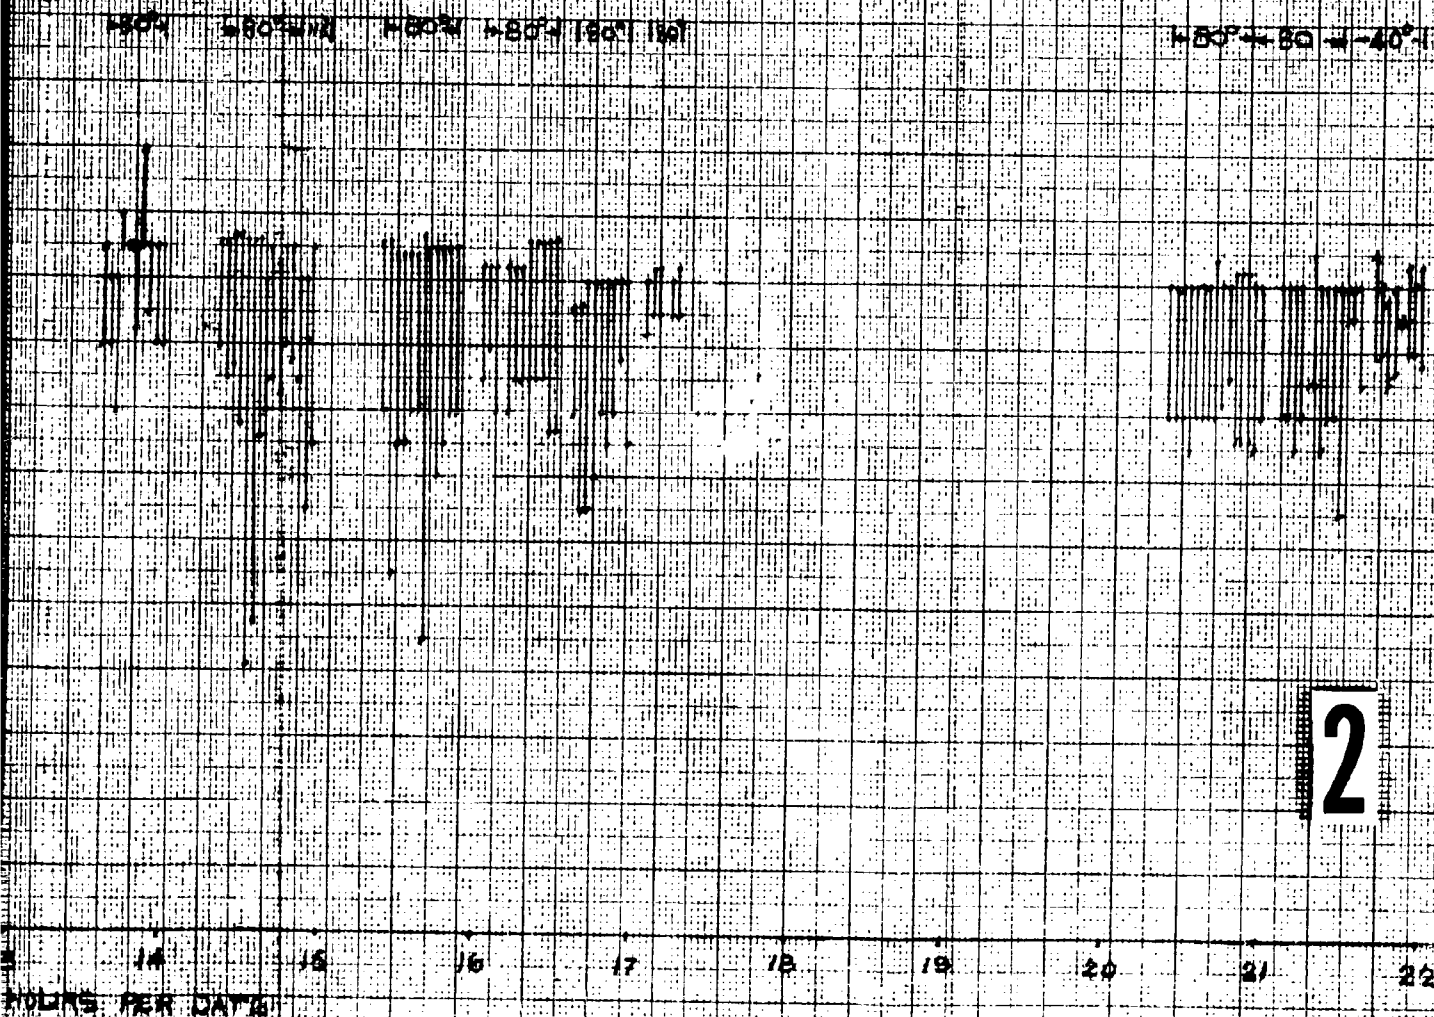
FIG 5

UNIT #3
AUTOMATIC NULL CIRCUIT
HOURLY METER RELAY READINGS
TOP LINE - BEGINNING OF CYCLE
BOTTOM - END OF CYCLE
CONNECTING LINES - RIN BLANK

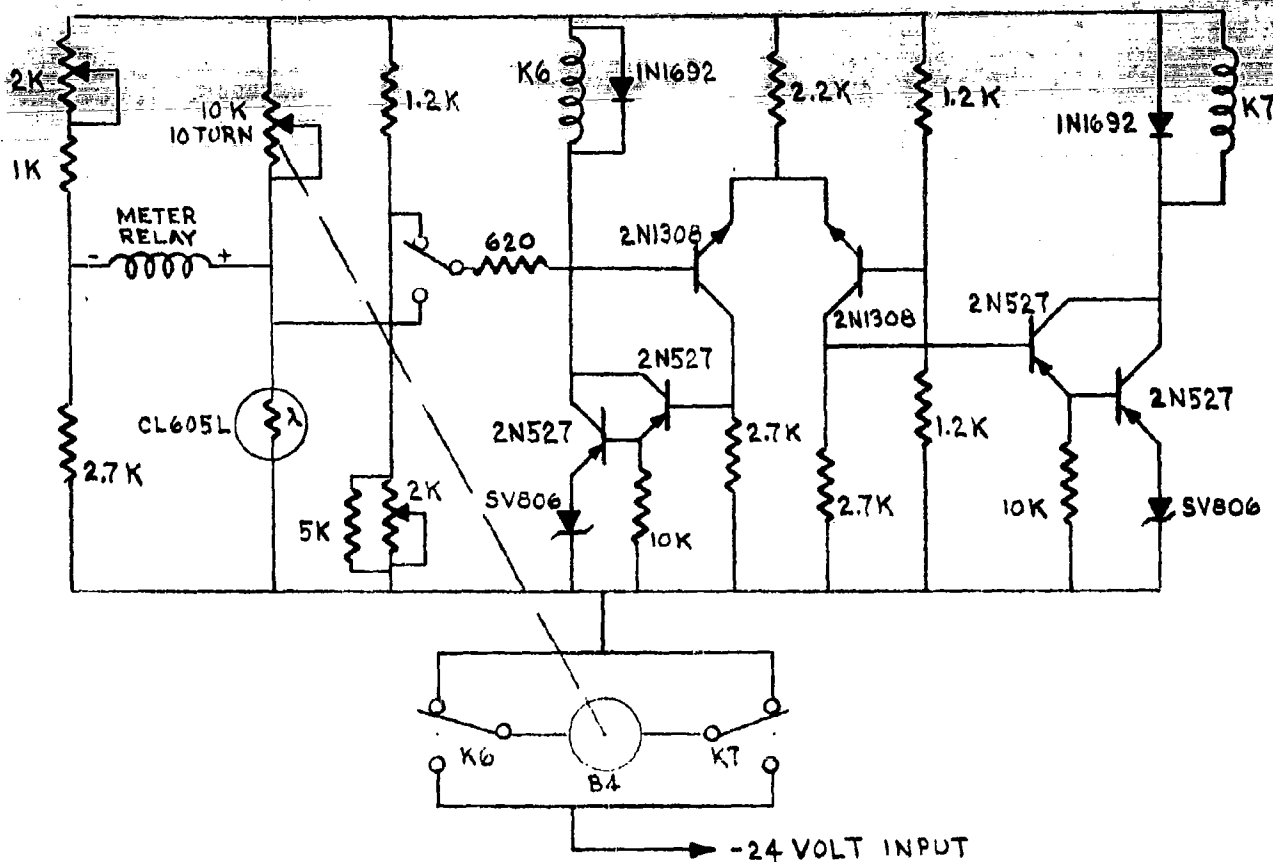
FIG. 4

basic idea is to amplify the meter current by the use of a differential amplifier and the use of current drivers for relay switching of the feedback motor. The feedback motor adjusts the resistor in series with the photocell until the voltages on both sides of the meter relay coil are equal. The circuit is able to renull to plus or minus 10 micro amps. The renulling circuit is connected to the meter relay for six seconds after transport and it is then removed. This switching action is accomplished by use of a microswitch actuated by the timer motor. See Figure 4.

This system was built for two units and was installed in units numbers 9 and 33. Unit number 33 was sent to CRDL for testing while unit number 9 is being tested in the AAI laboratory. As of 22 November unit number 9 had 134 hours of operation without a failure in the renull circuit. The hourly meter reading at the beginning and ending of a cycle was recorded and graphed. The resulting graph is shown as Figure 5. The graph shows that the renull circuit functioned properly by renulling to within plus or minus 10 micro amps of zero each cycle.

Improvements in this circuit should be investigated before any adaptation is done. Some of the areas for improvement are elimination of two transistors, elimination of the meter relay, elimination of one zenor diode, and additional design effort to optimize performance characteristics. These areas will be investigated during the next reporting period.

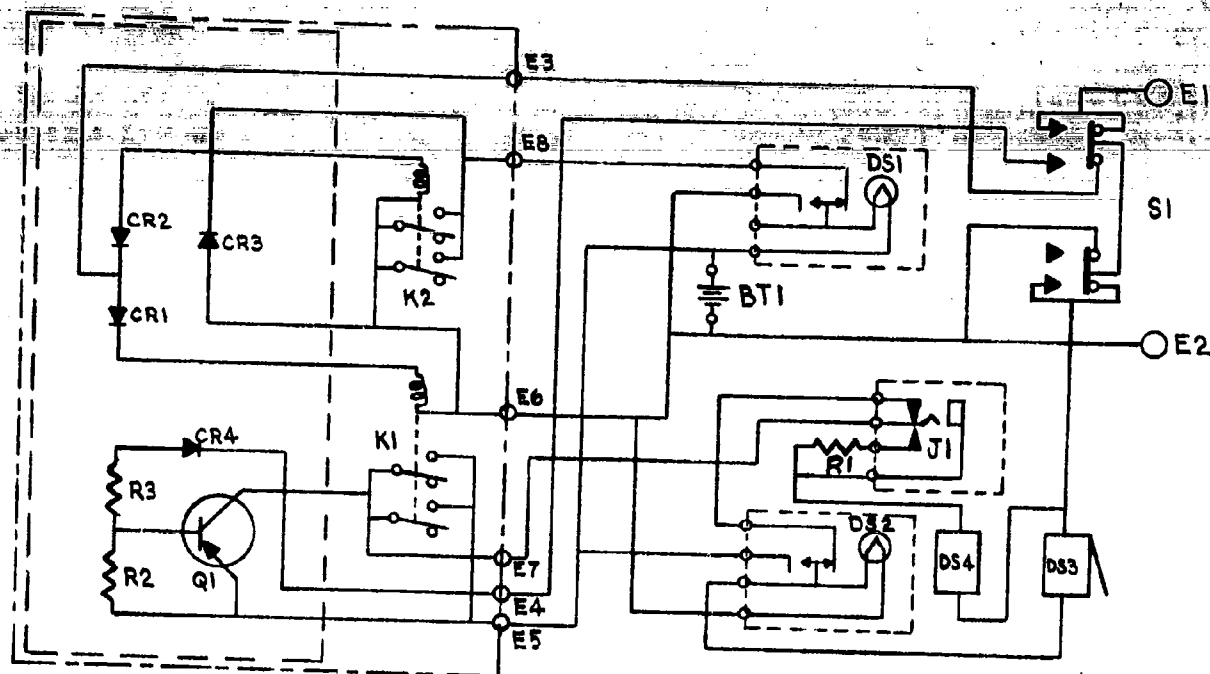
Figure 6

- (1) At higher temperatures, the danger of thermal runaway existed
- (2) The constant current drain on the batteries could require frequent replacement of the batteries
- (3) When giving an alarm indication, there was a one volt drop across the transistor, thus limiting the lower voltage to which batteries may be operated

For these reasons, the circuitry has been redesigned, as shown in Figure 6. Two sensitive relays detect the signals from the E41 alarm, while a transistor circuit is used for the continuity and polarity check. The revised circuit will exceed the performance of the all-transistor circuit.

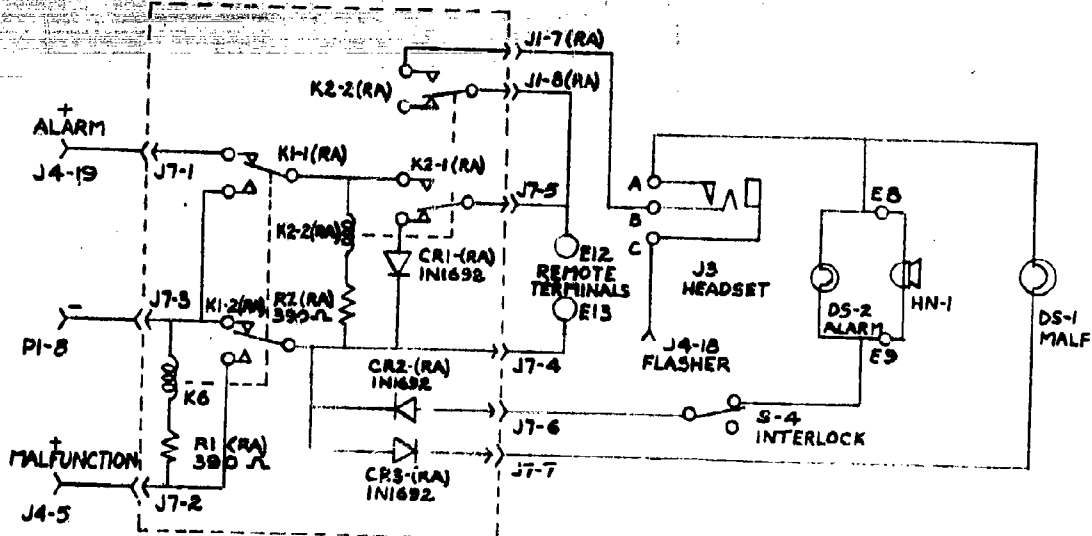
FIG 7

REVISED E41R2 WIRING TO ACCEPT E54R1 REMOTE CONTROL UNIT

Some rework of the present E41 alarm circuit is necessary to operate the E54R1 unit. This is shown in Figure 7. In addition, a new mounting plate is required for the input, headset and remote jacks.
